LASER/IPL TREATMENTS

**BEFORE
AND AFTER
PHOTOGRAPHS**

**WHAT YOU SHOULD EXPECT TO
SEE, AND WHAT YOU
SHOULDN'T SEE...**

DERMA-LASE
LASER & IPL TRAINING

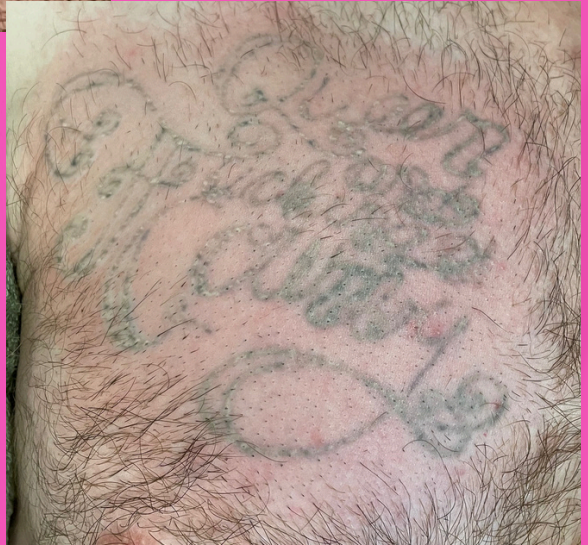
This process should be 'subtle', even though a significant amount of energy is applied to the skin. The photo to the right shows the typical reaction we should expect to see immediately after a treatment by a QS or picosecond laser.

If the laser energy is applied correctly, there should be no obvious signs of skin trauma or bleeding. Occasionally, some 'punctate' bleeding, known as 'petechiae' may be visible - small blood spots on the surface. However, there should not be any 'bleeding', as such. If you do see this, then you are not applying the laser energy correctly!

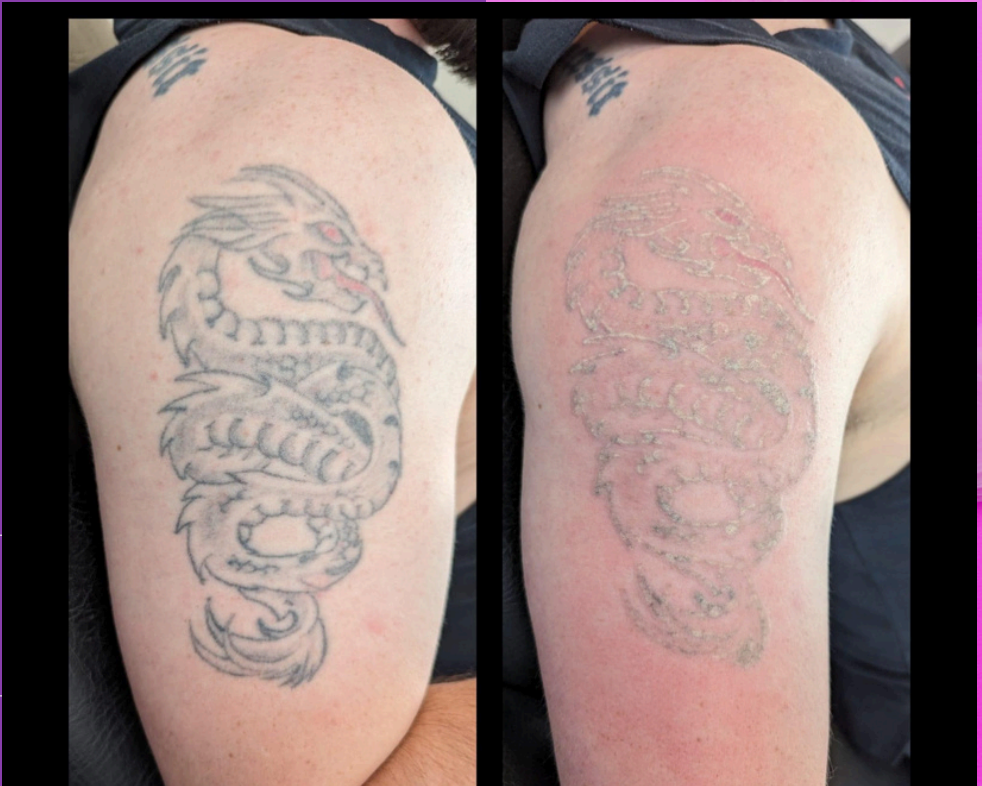
Here is a typical result following treatment with a nanosecond Nd:YAG laser. We can see some frosting, erythema and a little bit of swelling - all very normal after such a treatment.

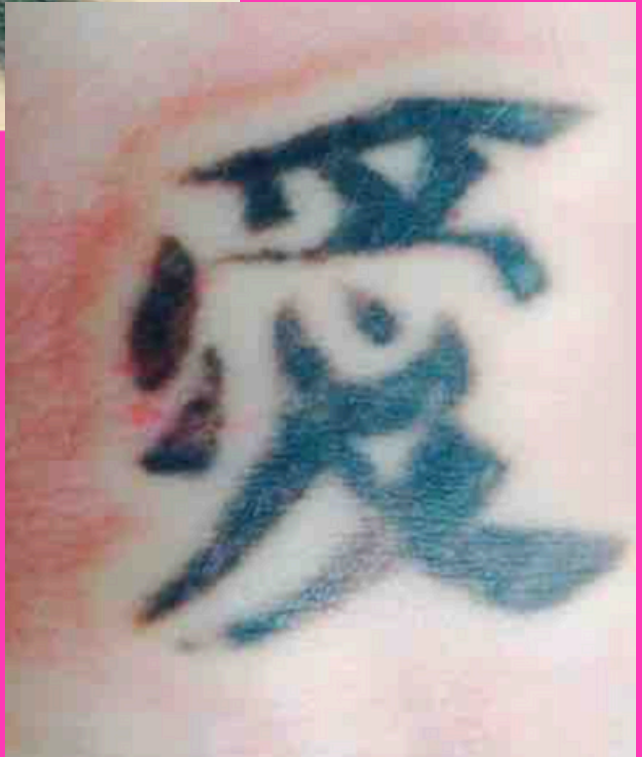
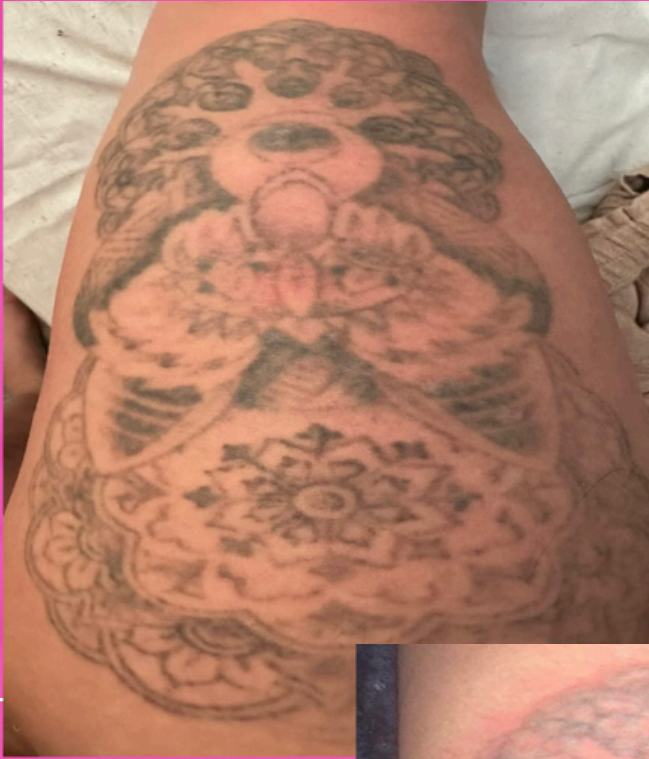
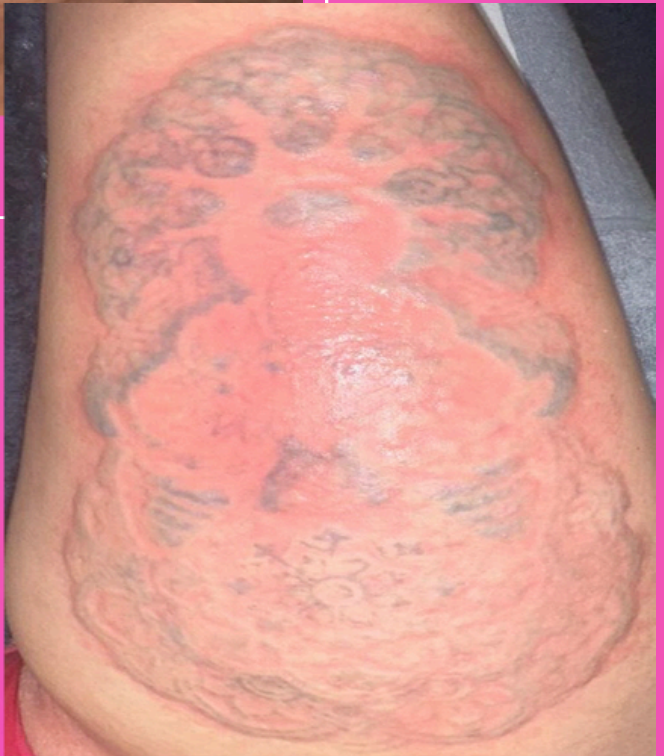
We can see the standard clinical endpoints here - erythema and oedema soon after the treatment.

The photo to the right is a perfect example of a post-laser tattoo treatment.

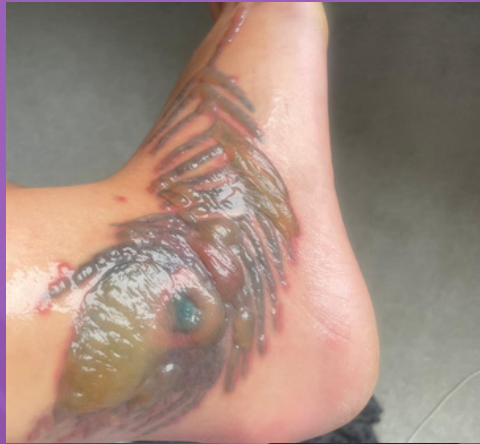
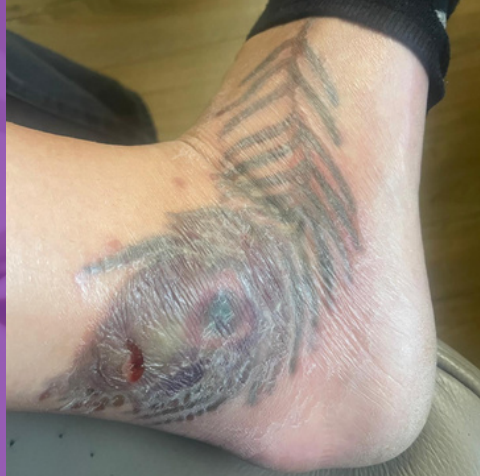
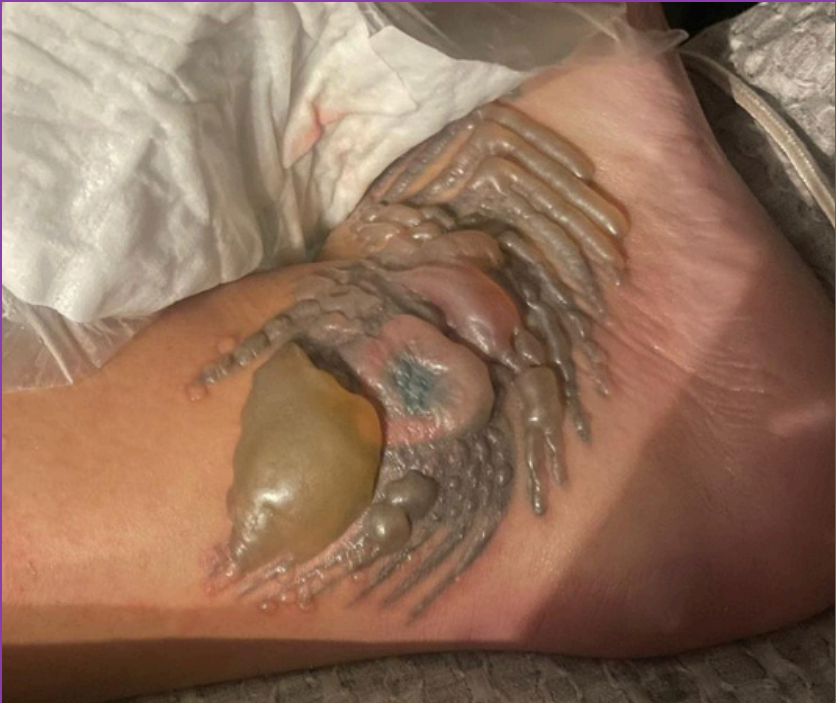
These pictures show a range of bad results including the loss of the epidermis (above) and excessive blistering or swelling (right).

The photo above shows a particularly bad blistering reaction after laser treatment. This kind of reaction usually indicates that too high a fluence was delivered - too much energy was deposited in the skin which induced unwanted thermal damage.

Occasionally, excessive blistering may occur when the ink particles are released back into the dermis, during treatment. If those particles of ink are toxic, they can induce a similar response.

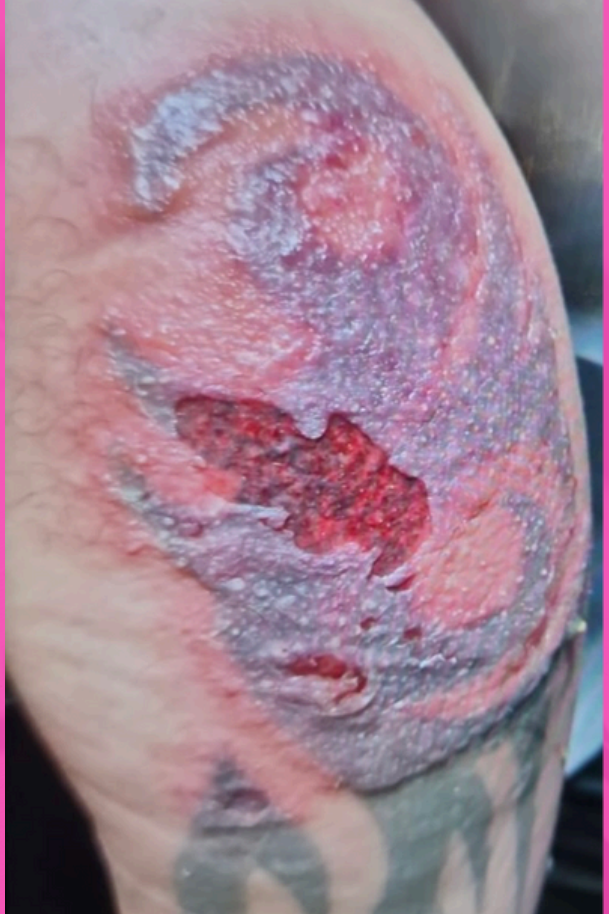
It is important that your patients/clients follow the aftercare instructions closely. This chap had his third laser tattoo treatment, then went to work in a very dirty environment. He was stripping the walls and ceiling in a shop. The air was obviously full of dust, dirt, bacteria etc. His tattoo was 'invaded' and this occurred!

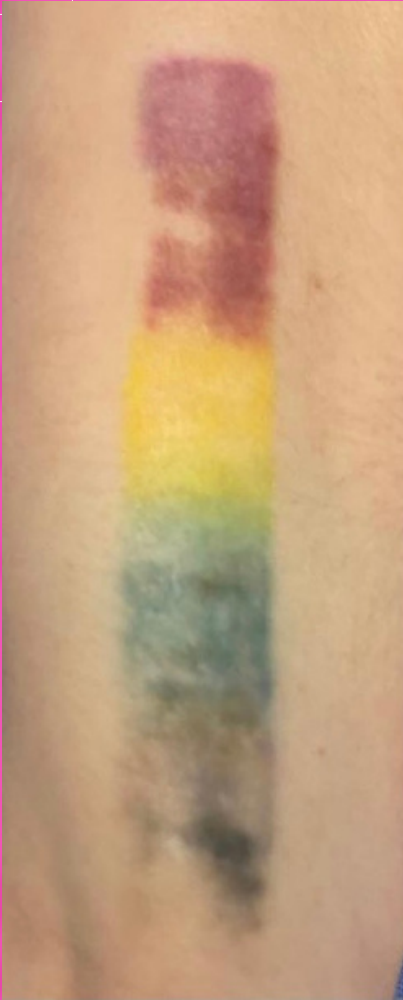
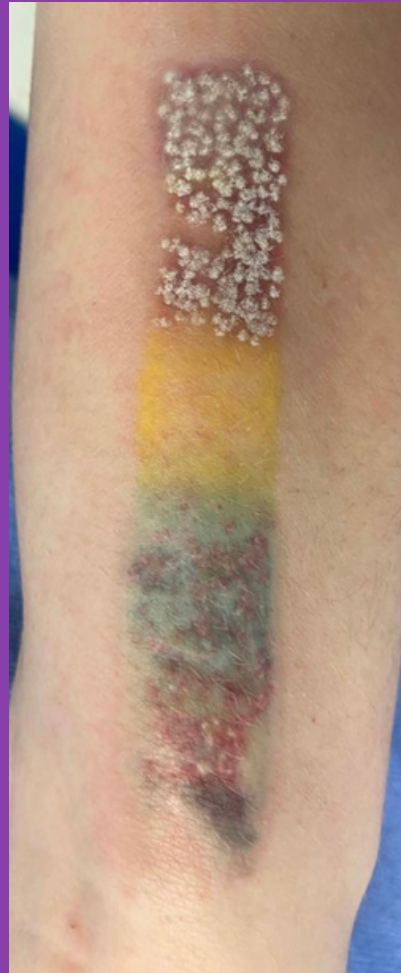
The above tattoo was treated using a Q-switched 532nm beam at a low fluence. The purpose was to see the reaction of the various colours to this energy.

It is interesting how the different colours reacted differently to the green 532nm beam. This is perfectly normal due to the various absorptions by the various pigments.

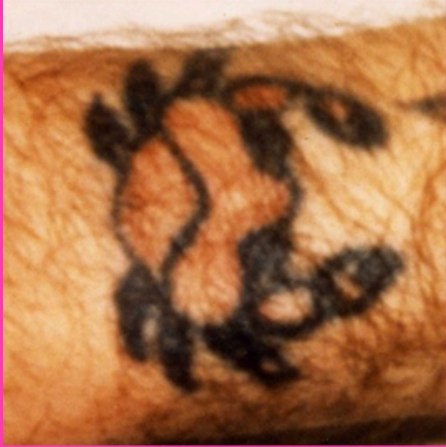
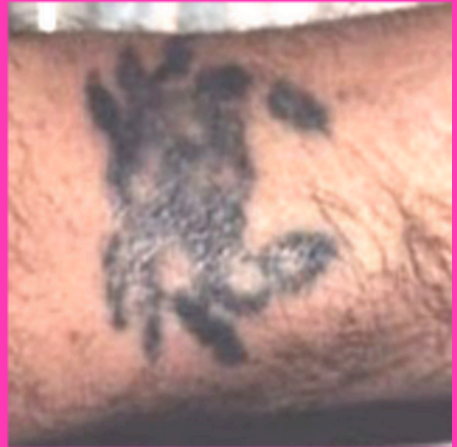
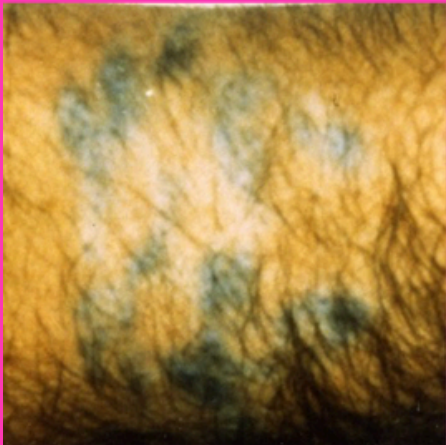
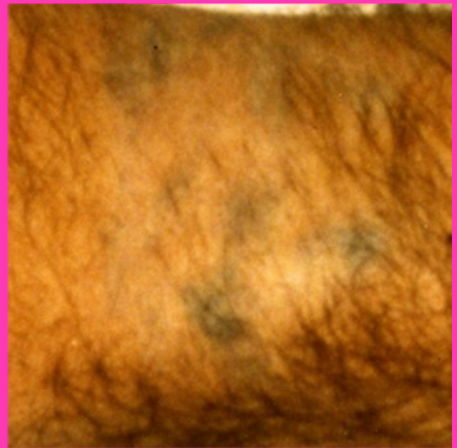
The red ink in the above tattoo changed to black after the first treatment session. This is simply due to one form of iron oxide (red) changing to another form (black), probably due to the heat.

As we can see above, treating the black ink caused it to fade. It is not usually a problem!

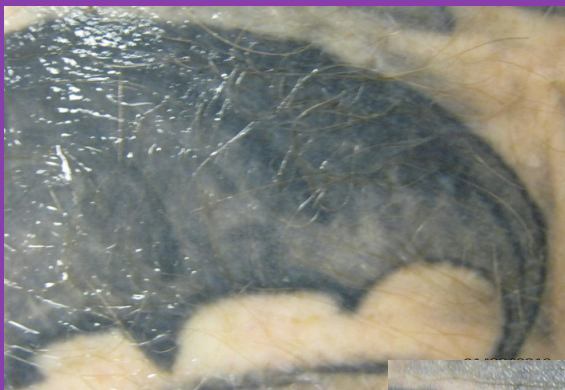
This tattoo was treated using the “R20” technique, using a QS Nd:YAG laser at 1064nm.

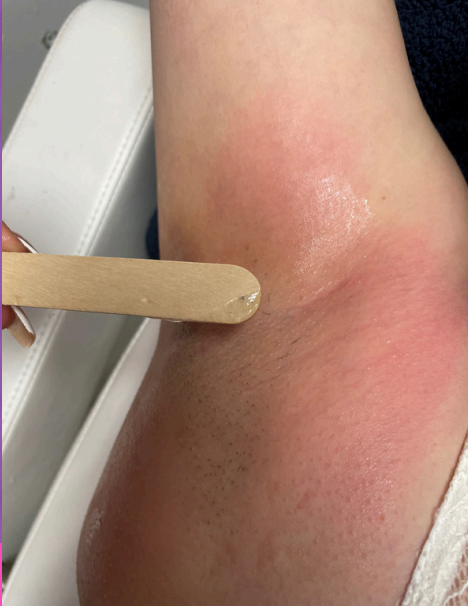
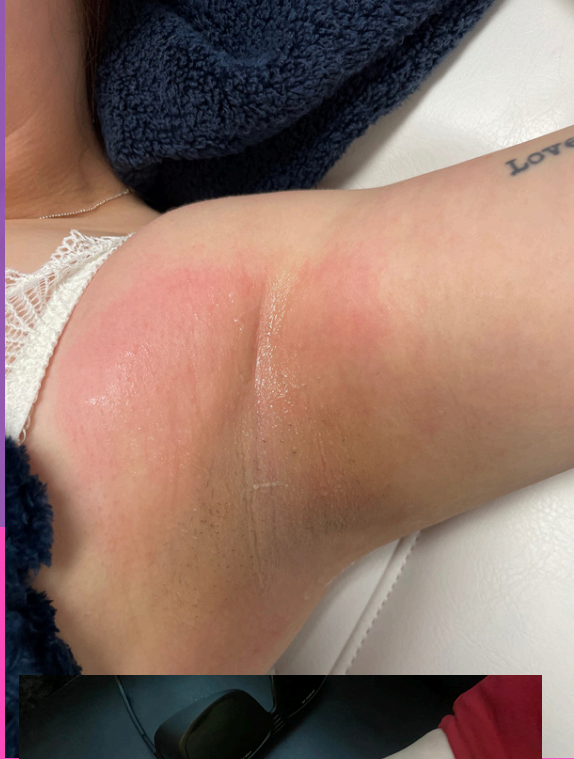
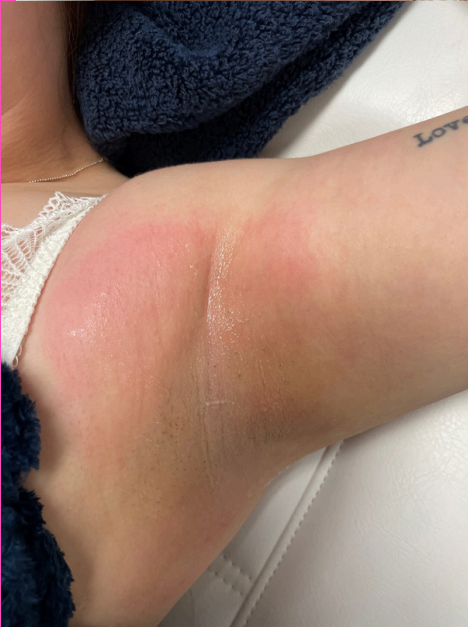
These photos show the erythema induced by ice cold packs on the skin. This is perfectly normal.

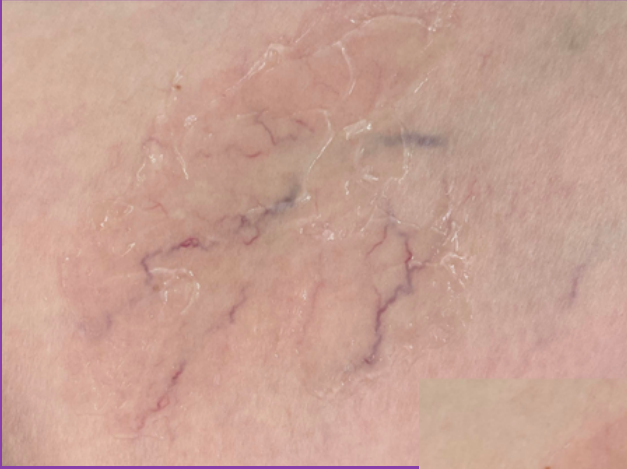
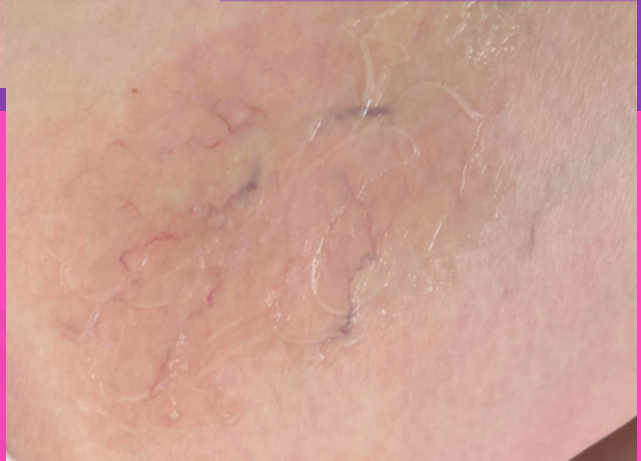
These vessels were treated using an IPL device. The vessels ranged in size, colour and depth.

The photo (right) shows that some of the vessels had shrunk immediately after treatment, but not disappeared completely.

Mike treated this area during a training session. On seeing the immediate result, he realised that he had not used sufficient fluence on these vessels.

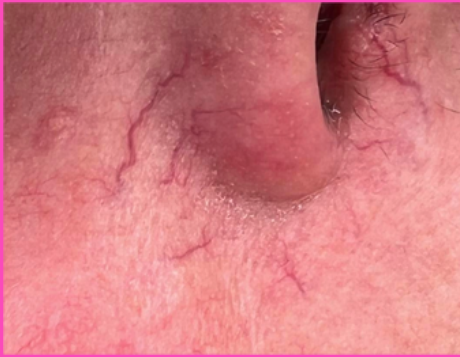
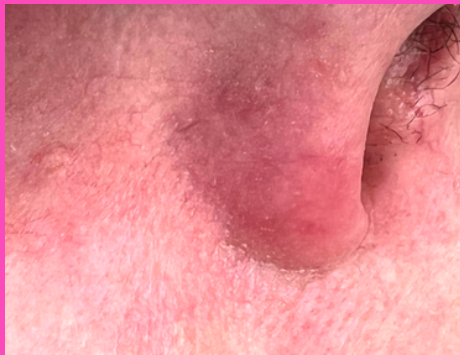
The photos (left) show some small telangiectasia (thread veins) before and after one treatment with an IPL using a 530nm filter.

These results are immediately after the treatment. Note the lack of any skin trauma due to the ice cooling before and after the application of the energy.

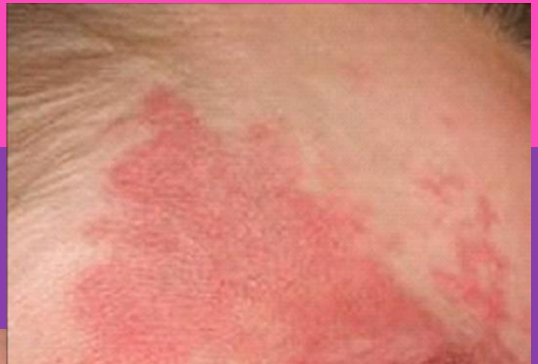
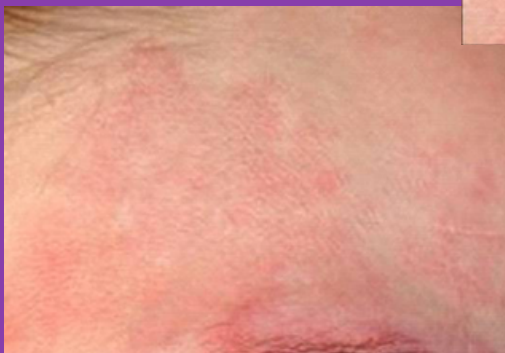
Port wine stain (PWS) birthmarks can also be treated using IPL light energy. They usually take more than one session, but, as we can see here, the results can be good.

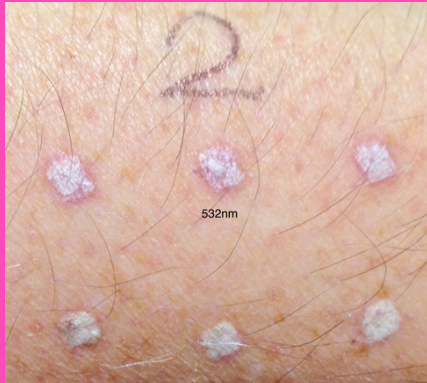
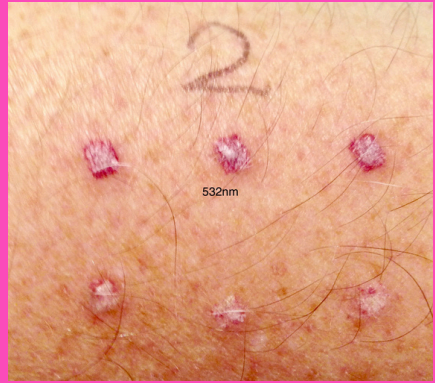
I fired a few shots of QS 532nm energy at my forearm, to see how it would interact with my blood vessels.

As expected, the light energy disrupted my capillaries inducing some 'blood blisters'. However, these faded after a few days leaving a perfectly normal skin.

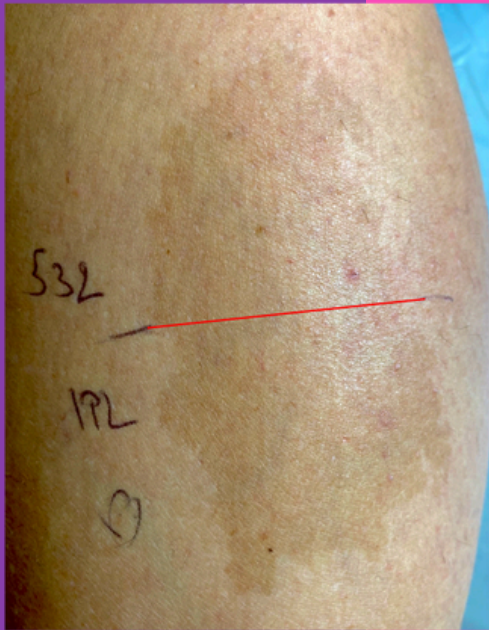
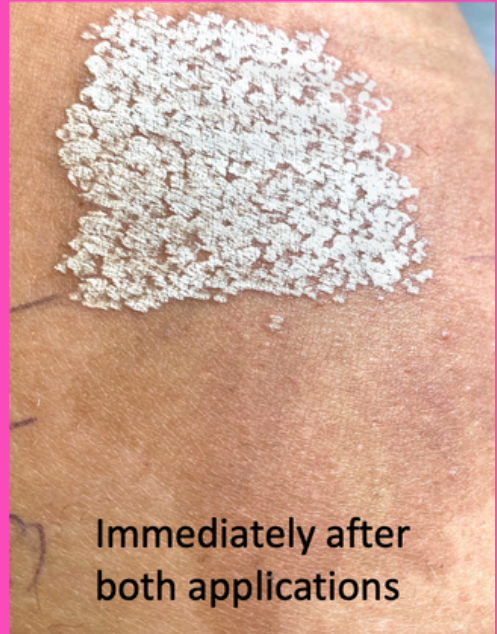
The above area shows a 'Café au Lait' pigmentation mark on the calf of a young lady's leg. We opted to treat the upper half with a Q-switched Nd:YAG laser with the 532nm wavelength at a fluence of 2 J/cm^2 .

The lower half was treated with an IPL using a 480nm filter and a fluence of 20 J/cm^2 in a 35ms pulse.

The photo on the right shows the different immediate reactions to these treatments - the 532nm energy has induced a response in the basal melanosomes, leading to 'frosting'. However, the IPL has apparently induced a much more subtle reaction in the skin.

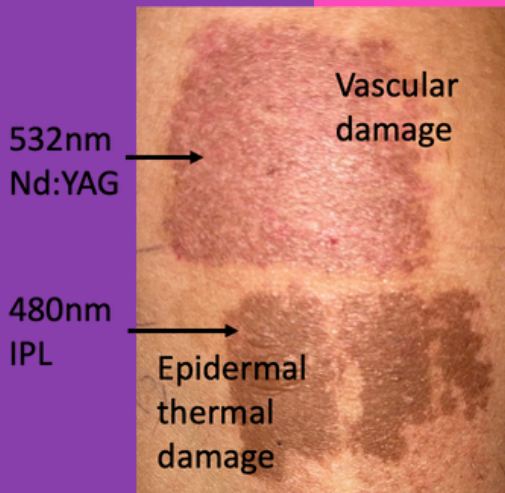
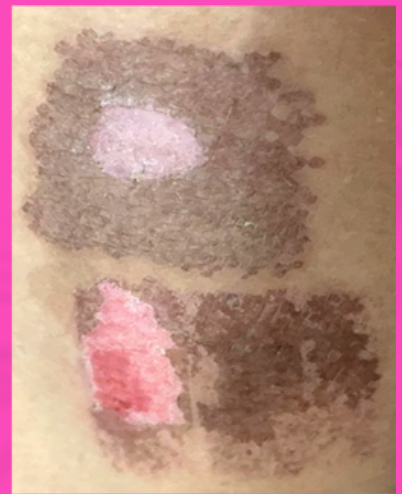
The next day we can see a marked difference in the skin's reaction to each treatment. The 532nm area is now exhibiting clear vascular damage, since capillaries are easily damaged by this wavelength. The IPL-treated area, however, shows more of a blistering reaction, as the epidermis has been clearly damaged.

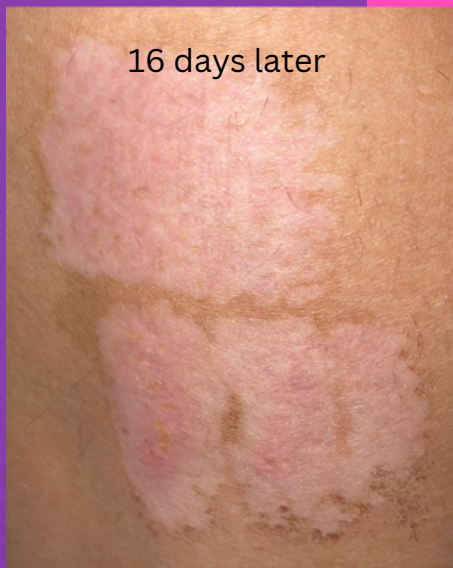
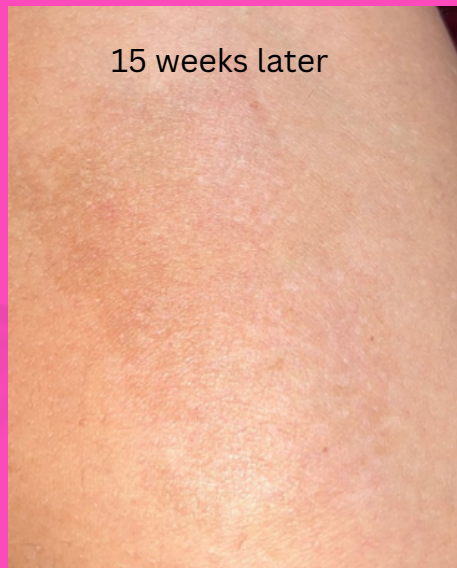
The final result at 15 weeks, shows that the same endpoint was reached, using both treatment modalities.

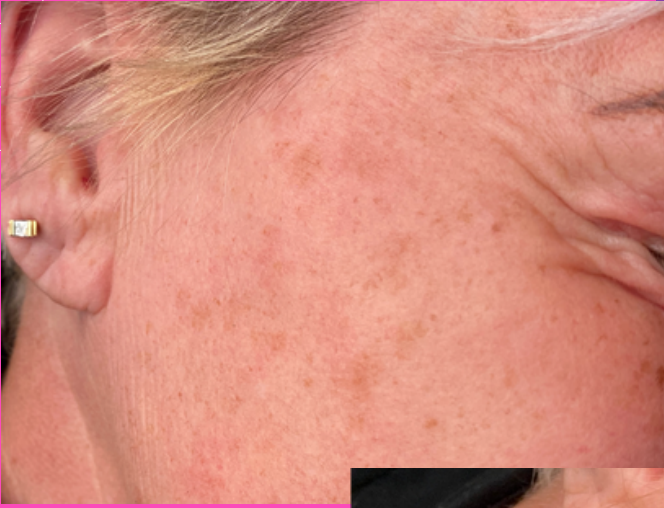
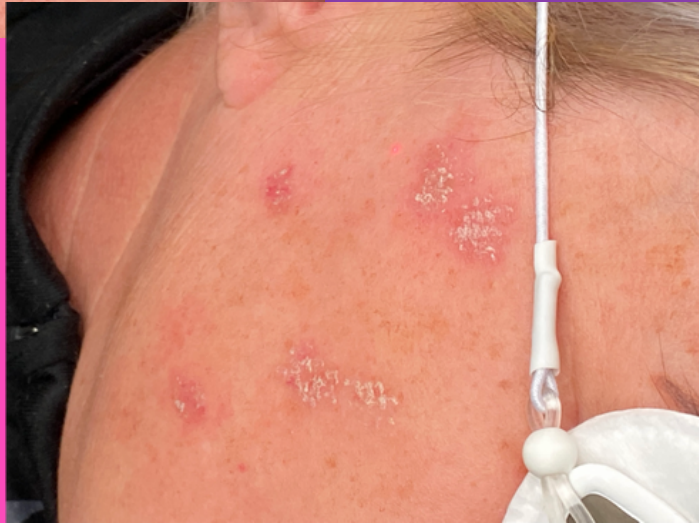
This lady was treated using the QS 532nm beam from an Nd:YAG laser at a low fluence.

Again, we see the frosting occurring from steam formation on the melanosomes, with a little erythema.

These all subsided within a few hours and the skin healed over subsequent days.

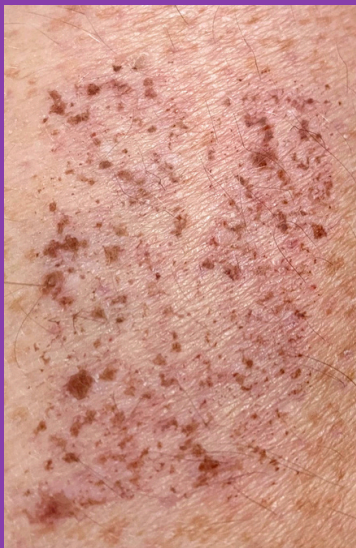
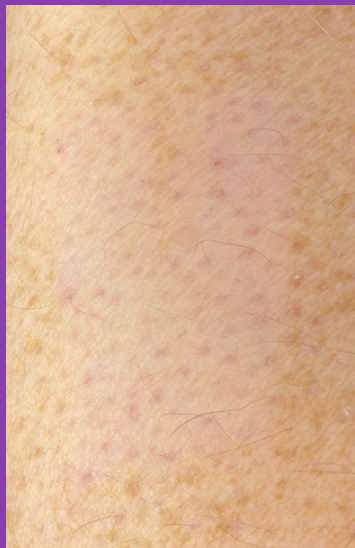
The above photos show an area immediately after being exposed to some IPL light energy. Some minor vascular damage is observed and a little pigmentation too. However, after a few days, the skin had fully recovered and some lightening of the skin is now evident.

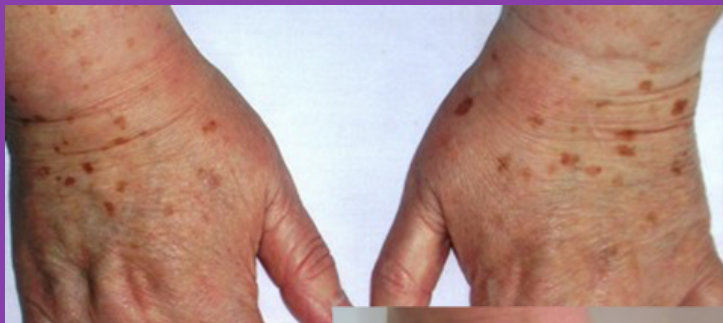
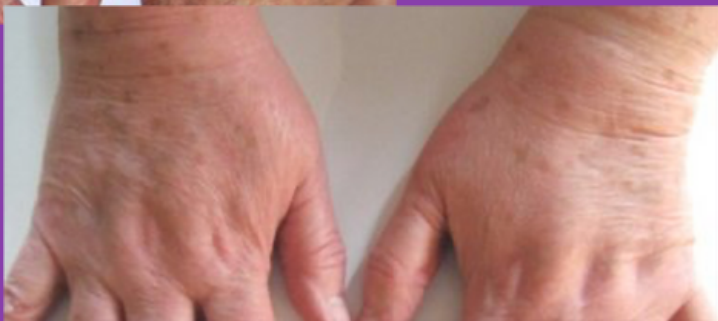
This lady exhibited age spots on her hands.

She had one session of QS Nd:YAG at 532nm and one session of IPL with a 480nm filter, a few weeks later.

The result after these sessions was a significant clearance of the pigmentation.

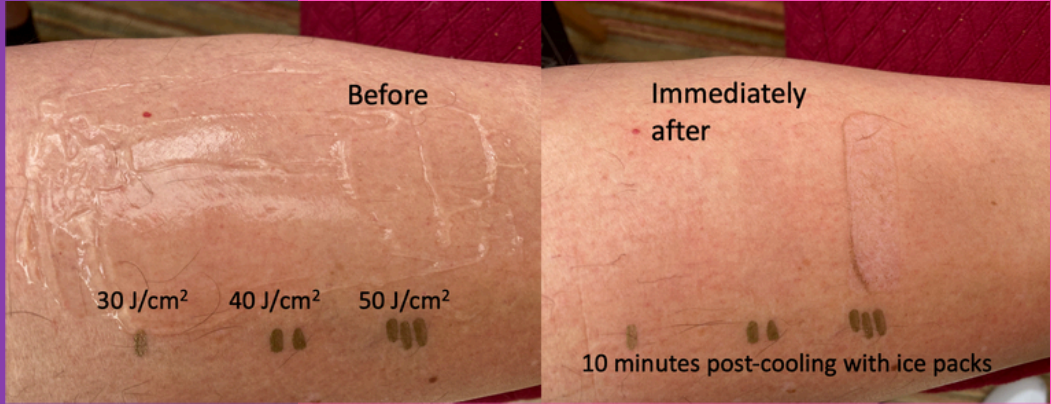
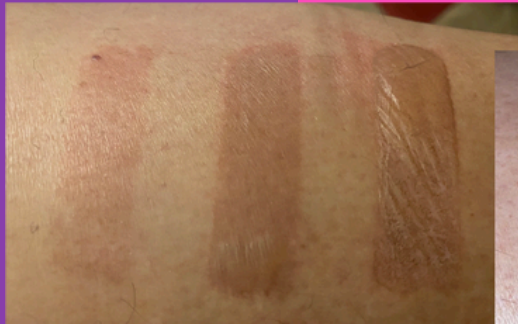
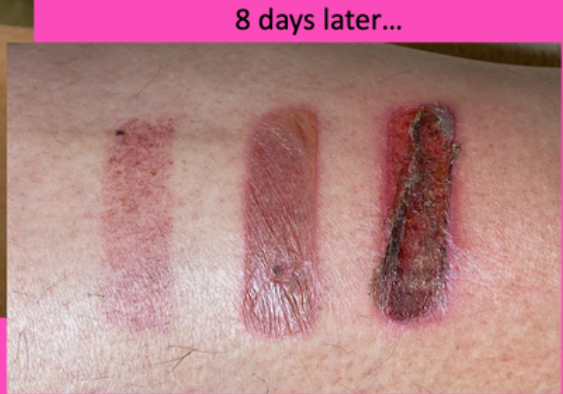
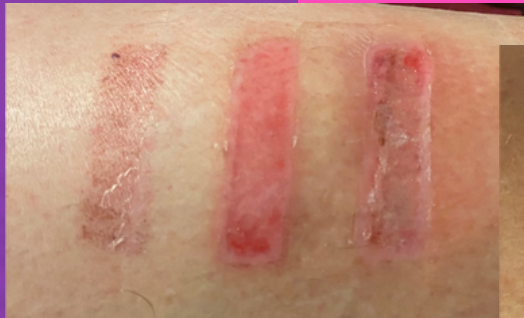
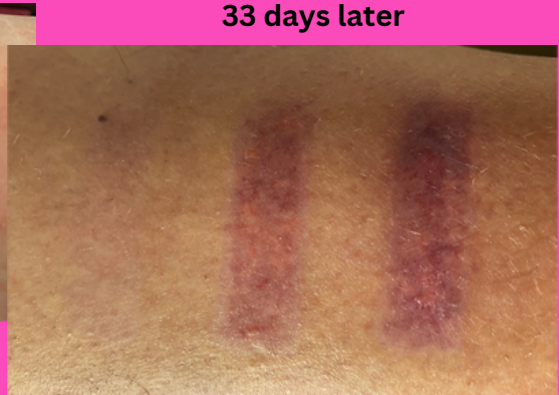
This lovely lady (Mike's wife!) agreed to a wee test on her leg with an IPL unit. He fired one shot of 30, 40 and 50 J/cm² on her leg with a 430nm filter. This allows through virtually all of the light energy from an IPL Xenon lamp, including all the blue light.

Blue light is very strongly absorbed in melanin, as can be seen in these photos! The 40 and 50 J/cm² areas were significantly damaged.

However, over time all three areas healed. After around 2 years, there is very little sign of damage, and no scarring.

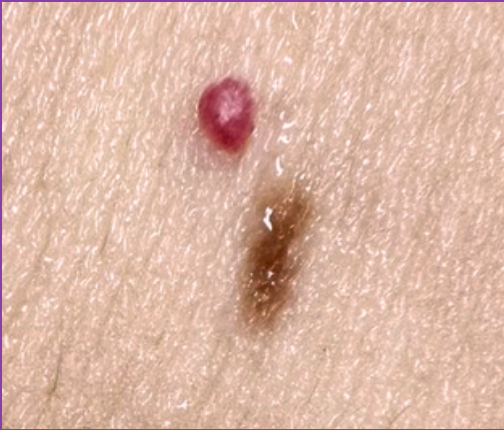
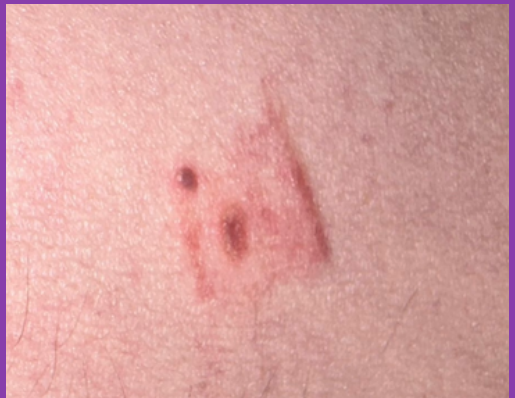
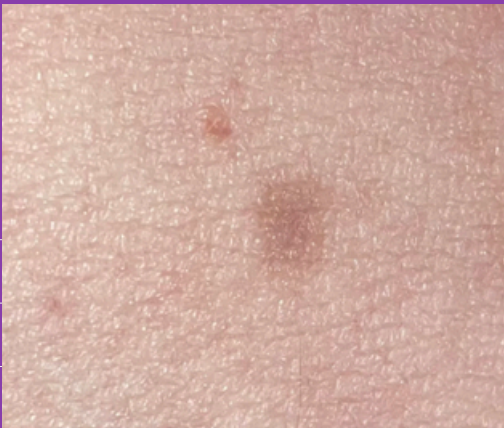
This photo shows a small blood spot and a pigmented lesion which were both treated simultaneously using an IPL with a 480nm filter at 40 J/cm² (pre-cooled with ice.)

Here we see two 'track lines' which can occur sometimes with IPLs - these are marks left by the metal cooling plates which are often found on either side of the output tip.

This was the result after four sessions spaced at around three month intervals. The track lines have disappeared and the lesions are almost gone.

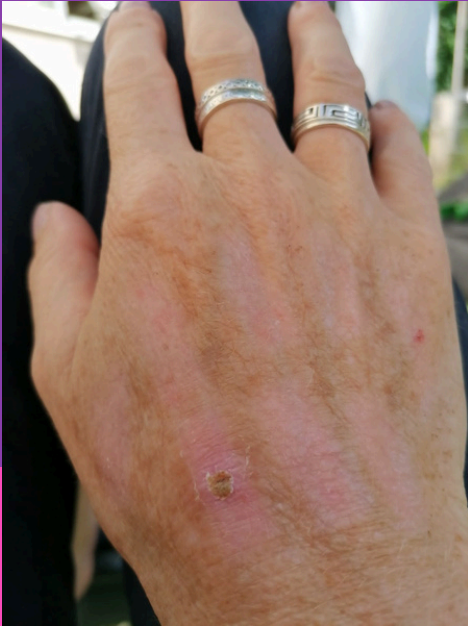
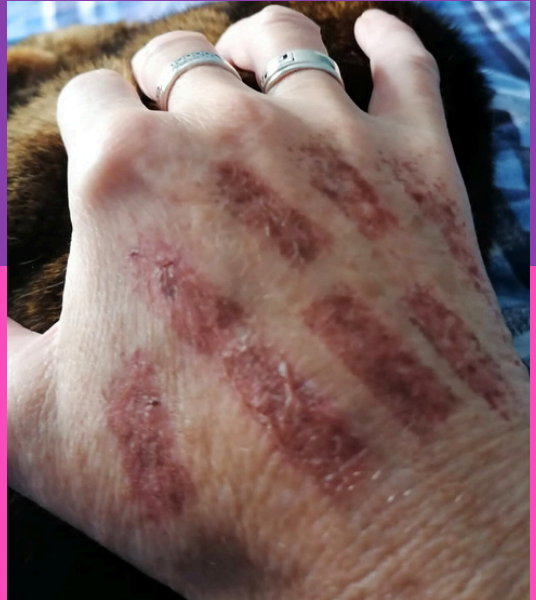
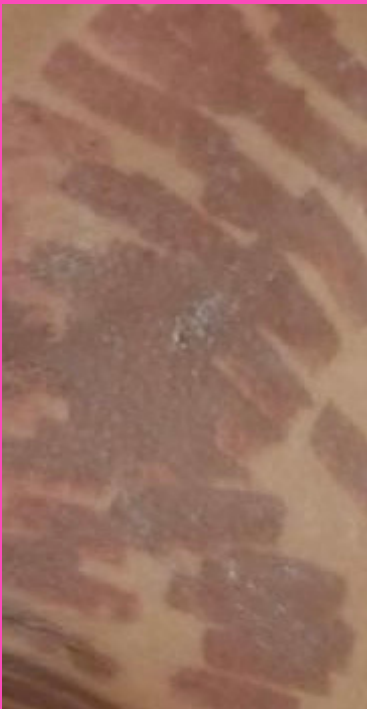
Here we see examples of IPL burns when the skin has not been properly pre-cooled with ice packs.

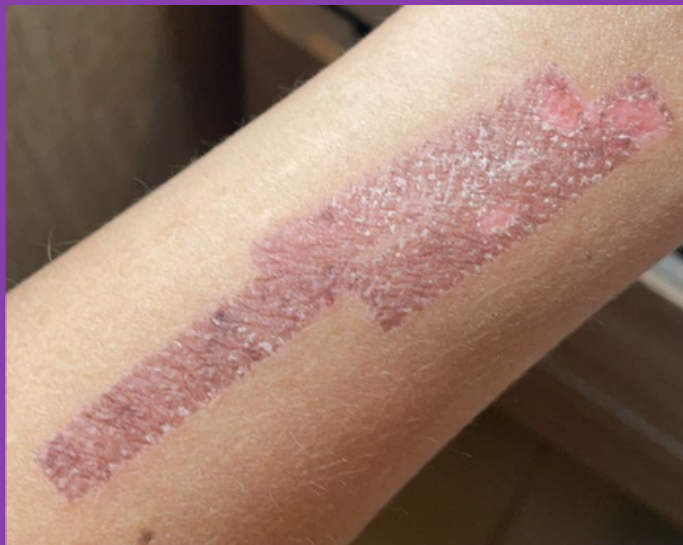
The photo (left) here shows what can occur if there is insufficient skin pre-cooling. The epidermis is clearly damaged through excess heating of the basal layer by the light energy.

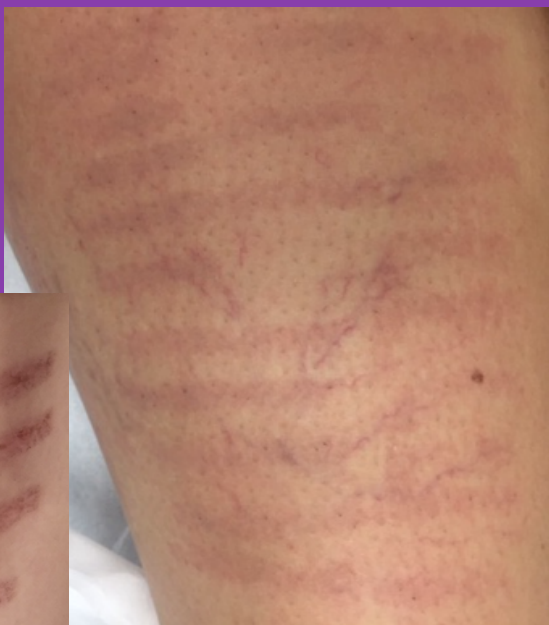
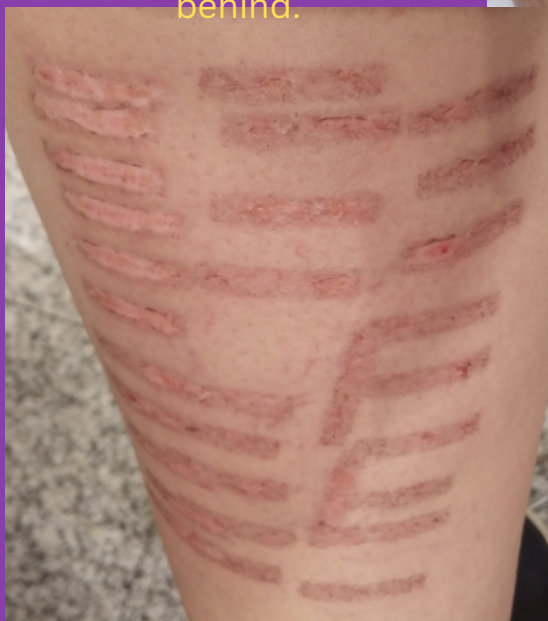
This photo (right) show the skin after a treatment by IPL. About a week later, much of the epidermis had fallen off leaving some slight burn marks behind.

However, these all healed up over the subsequent weeks. Pre-cooling with ice would likely have prevented these reactions.

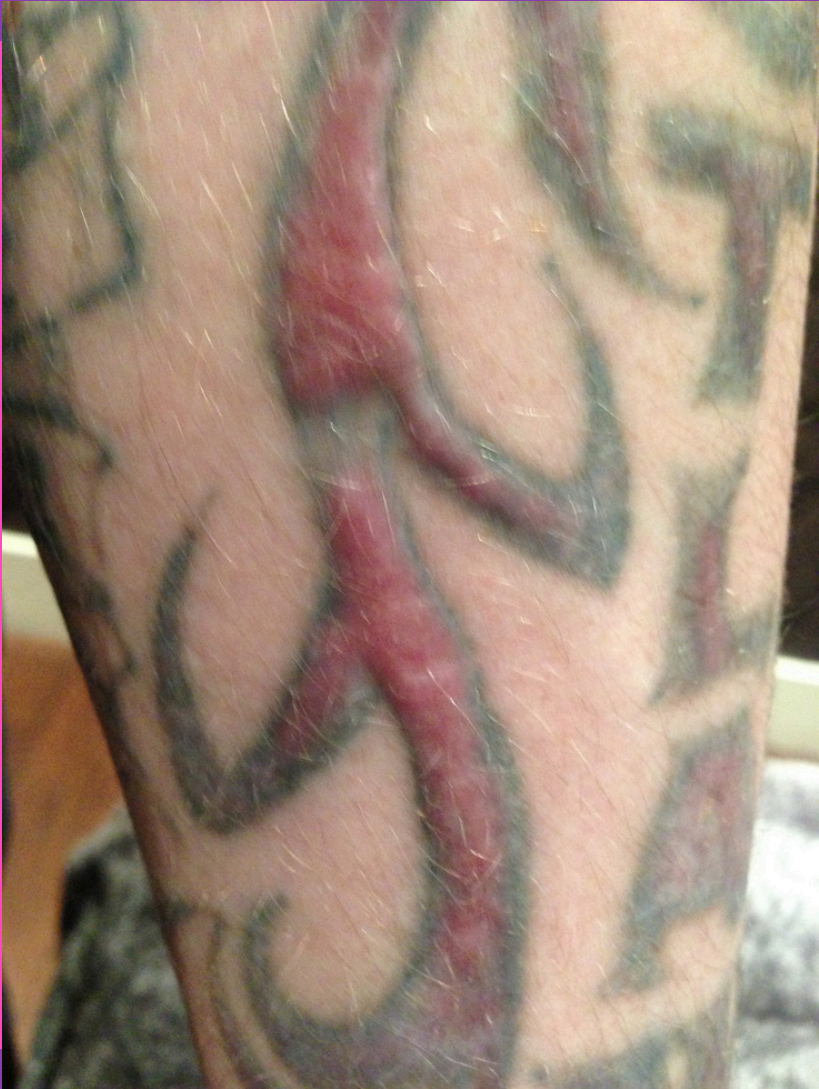
This tattoo has been treated with too high a fluence which has induced scar formation. This is unlikely to clear by itself, and will likely be permanent.

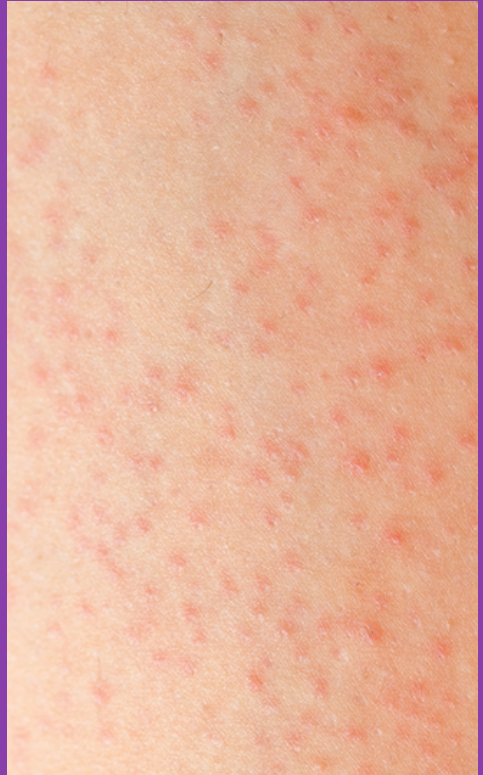
However, a commonly seen issue is folliculitis (above). This is a typically standard reaction to this treatment and usually does not cause any untoward problems. As long as the patient/client follows the proper post-care treatment instructions, they should be fine. This condition may last for a few days, but seldom longer.

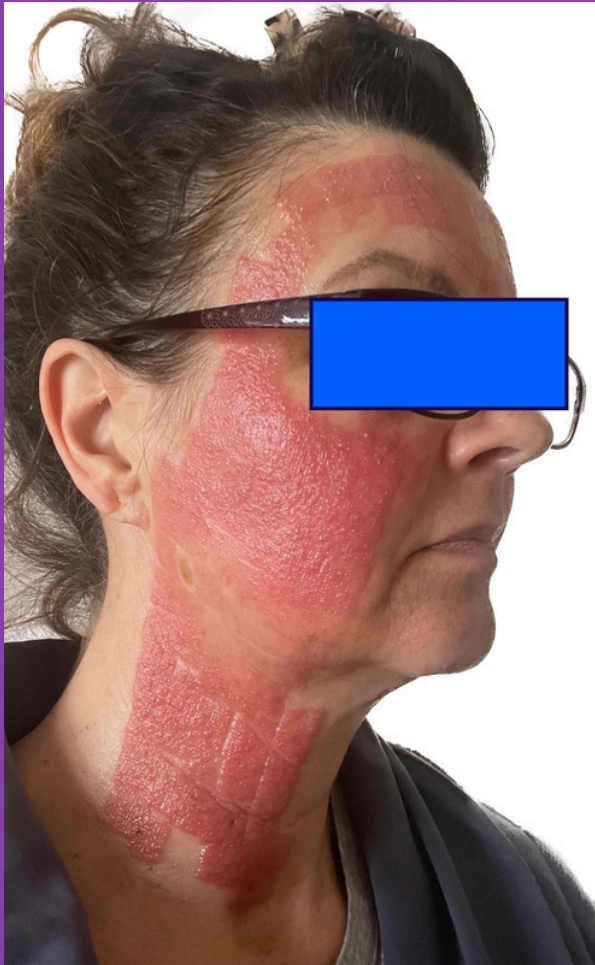
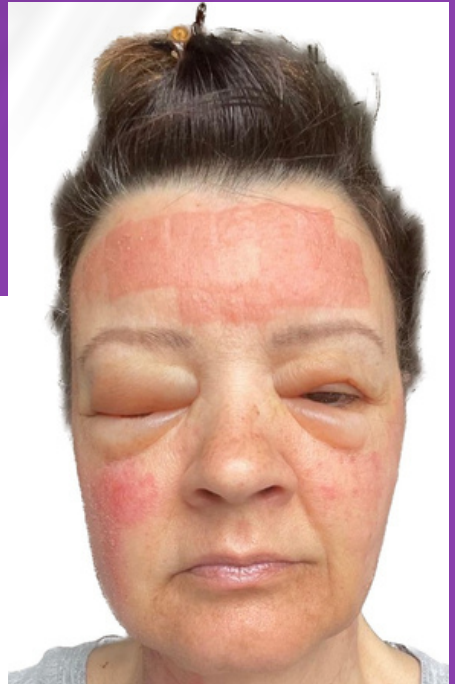
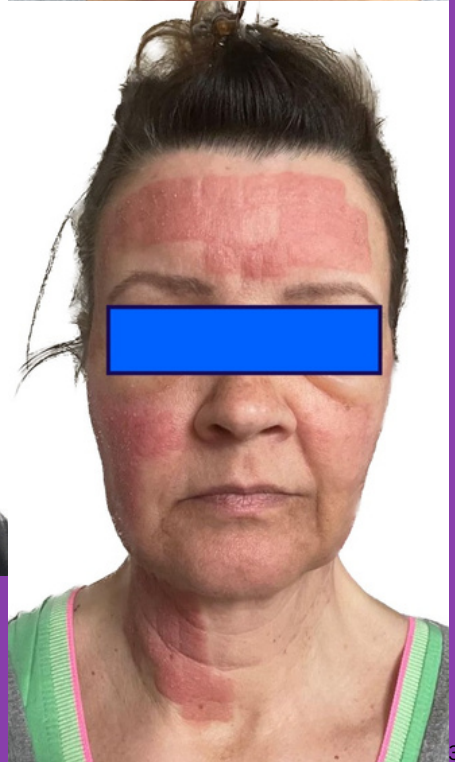
CO2 treatments can be quite 'aggressive', as seen here. The above photo was taken only around 48 hours after the treatment.

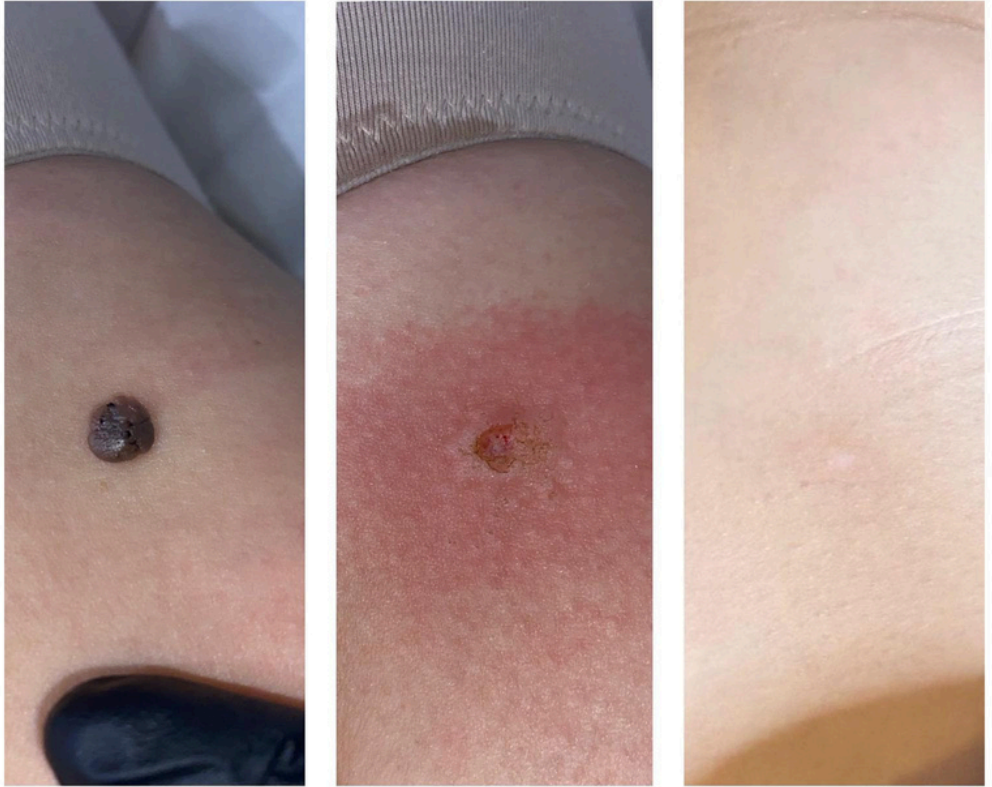
This pigmented lesions was checked prior to treatment and found to be benign. A simple and quick CO2 laser treatment removed it easily with no significant trauma. The final result, after two weeks, shows how effective this treatment is.
